Name Of Dam: WOODSTOCK

Location: SHENANDOAH COUNTY, STATE OF VIRGINIA

Inventory Number: VA 17104

PHASE I INSPECTION REPORT

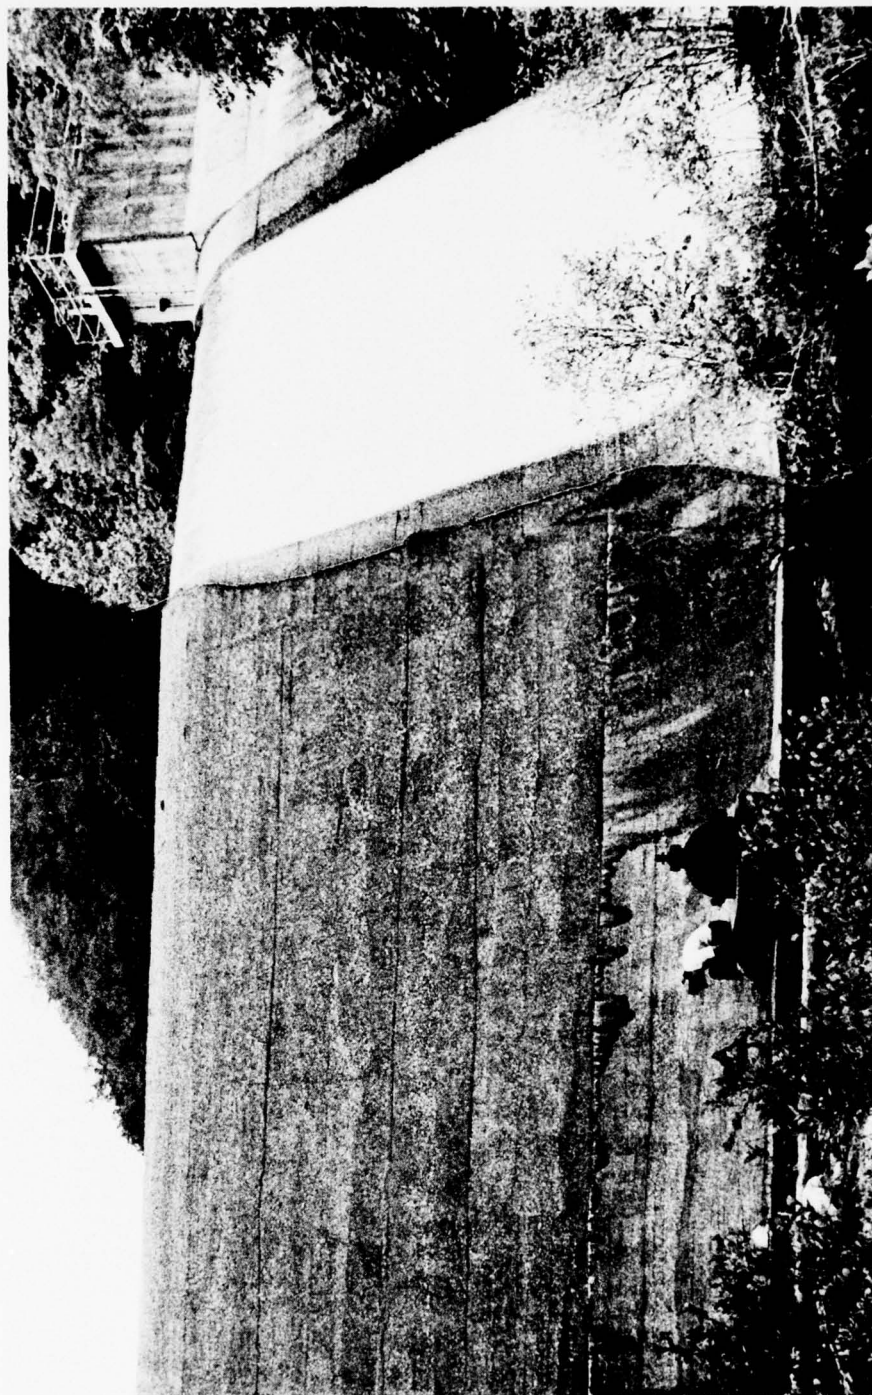
OVERALL VIEW OF DAM

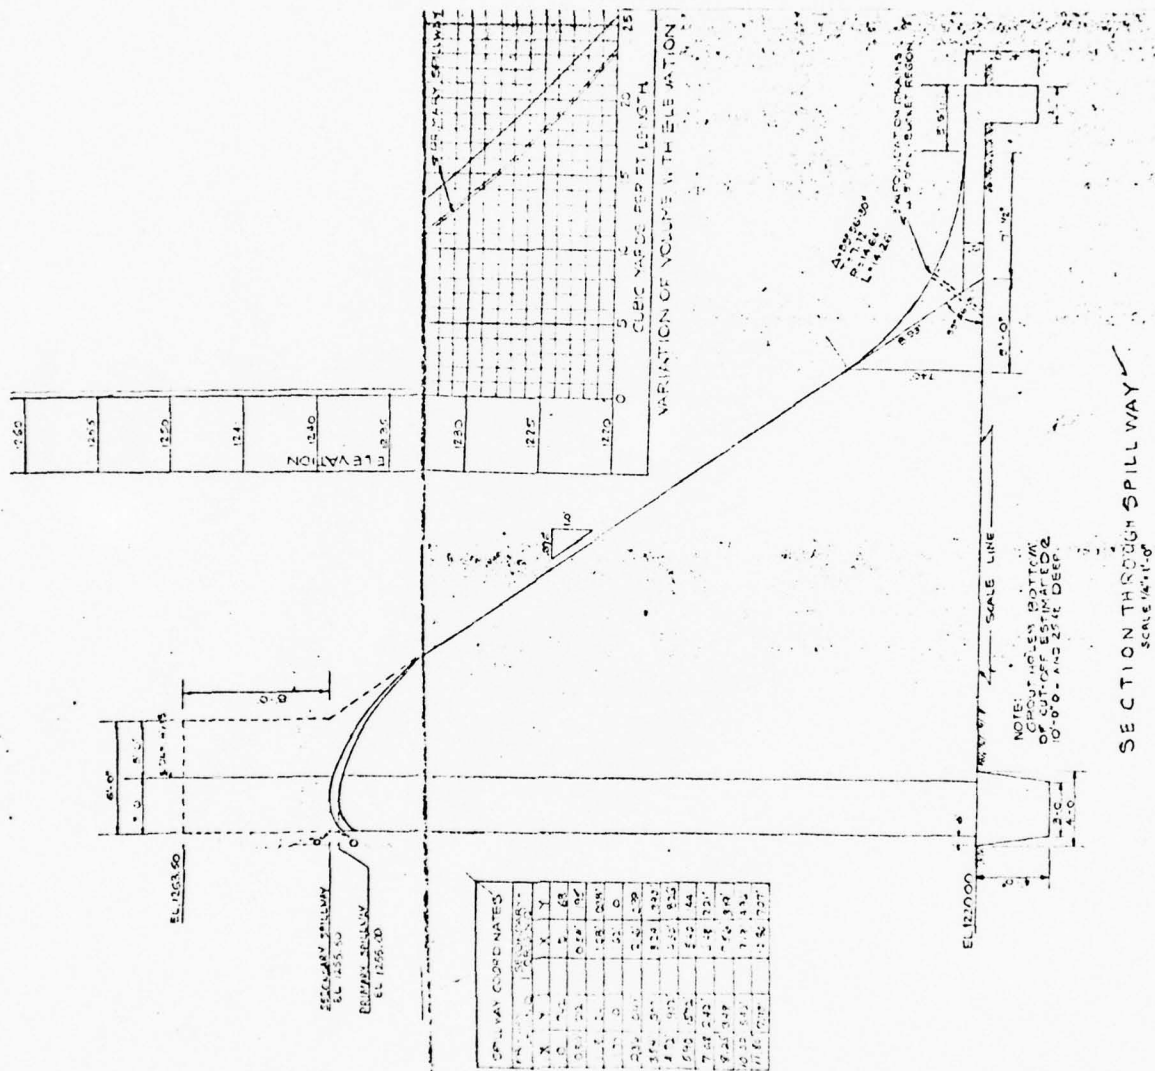
PLATE 3

SECTION THROUGH SPILL WAY

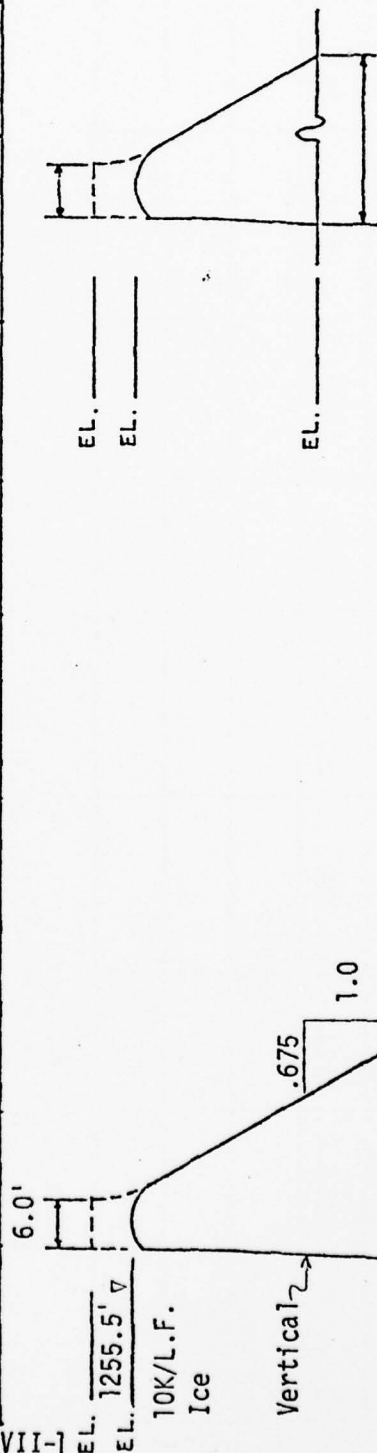
PARTIAL SECTION

LOADING CASE	ELEV. HEAD WATER	ELEV. TAIL WATER	ΣV	ΣH	$\frac{\Sigma H}{\Sigma V}$	LOCATION RESULTANT FROM TOE	% BASE IN COMPRESSION	FACTOR SAFETY SLIDING	FOUNDATION PRESSURE	
									TOE	HEEL
I	1255.5	1220	74,194	48,281	.65	9.39	94	10.8	5267	0
Ice Load Normal Pool

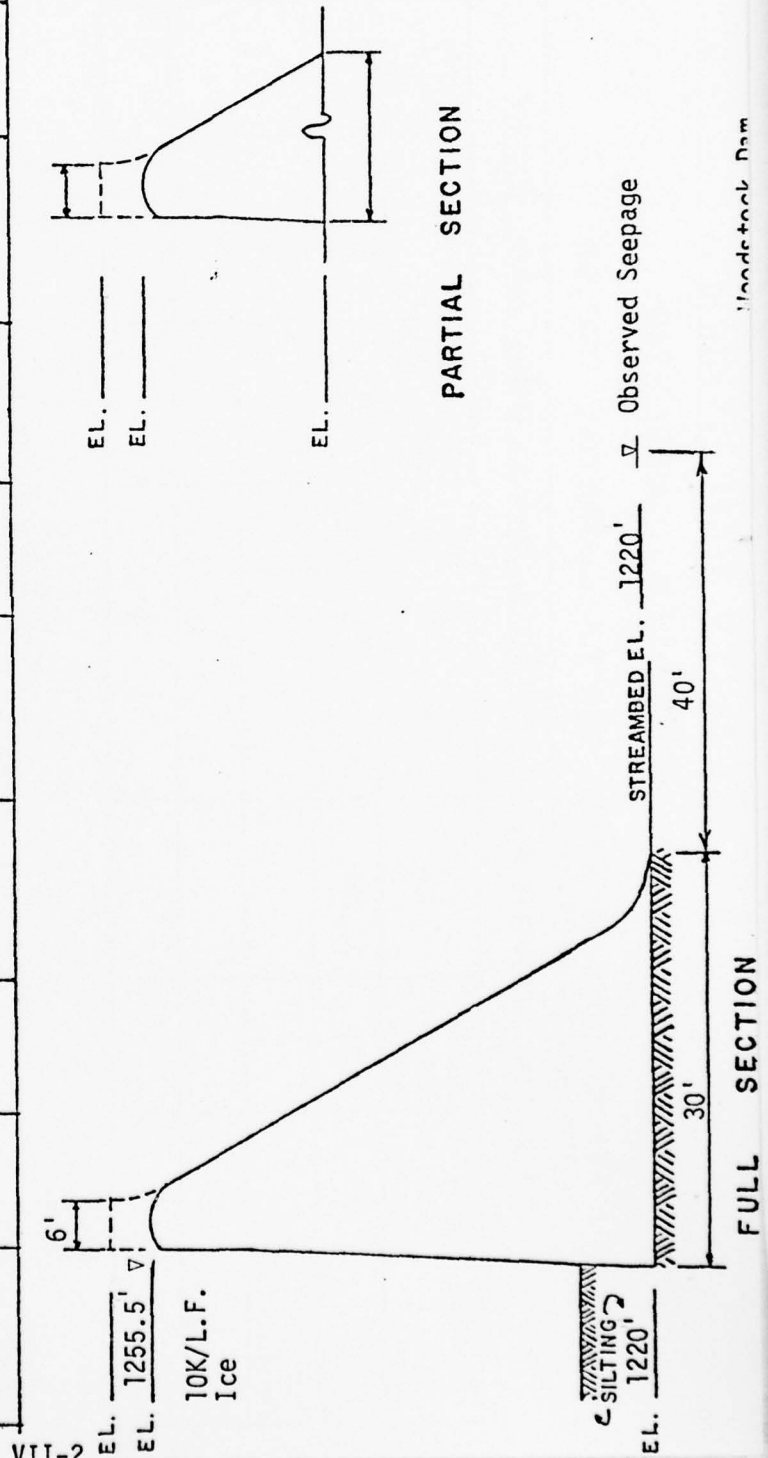
LOADING CASE	ELEV. HEAD WATER	ELEV. TAIL WATER	ΣV	ΣH	$\Sigma H / \Sigma V$	LOCATION RESULTANT FROM TOE	% BASE IN COMPRESSION	FACTOR SAFETY SLIDING	FOUNDATION PRESSURE	
									TOE	HEEL
II	1255.5	1220	61,286	48,281	0.79	9.22	92	10.5	4431	0
Ice Load										
Normal Pool										
Added Uplift Pressure

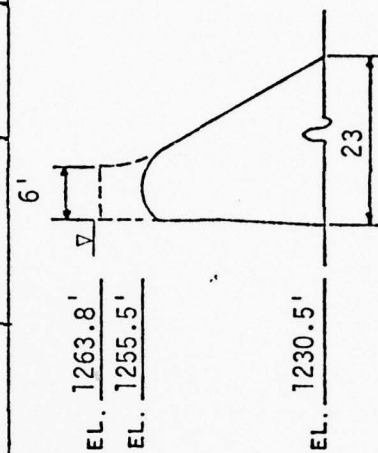
PARTIAL SECTION
CASE IIIA

LOADING CASE	ELEV. HEAD WATER	ELEV. TAIL WATER	ΣV	ΣH	$\frac{\Sigma H}{\Sigma V}$	LOCATION RESULTANT FROM TOE	% BASE IN COMPRESSION	FACTOR SAFETY SLIDING	FOUNDATION PRESSURE	
									TOE	HEEL
III	1263.8	1225	62,606	55,031	0.88	7.95	80	9.1	5250	0
Water at top of non-overflow section										
IIIA Partial Section	1263.5	-	41,290	32,030	0.78	7.1	92	47.8	-	-
